BRANT LAKE UPPER DAM

WARREN COUNTY, NEW YORK  
INVENTORY No. NY 158

PHASE I INSPECTION REPORT  
NATIONAL DAM SAFETY PROGRAM

UPPER HUDSON RIVER BASIN  
BRANT LAKE UPPER DAM  
I.D. No. NY - 158 (#652)  
PHASE 1 INSPECTION REPORT

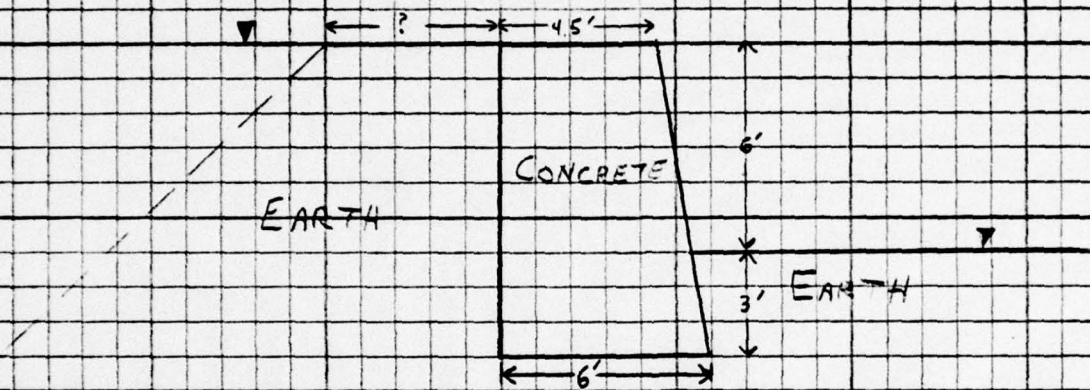
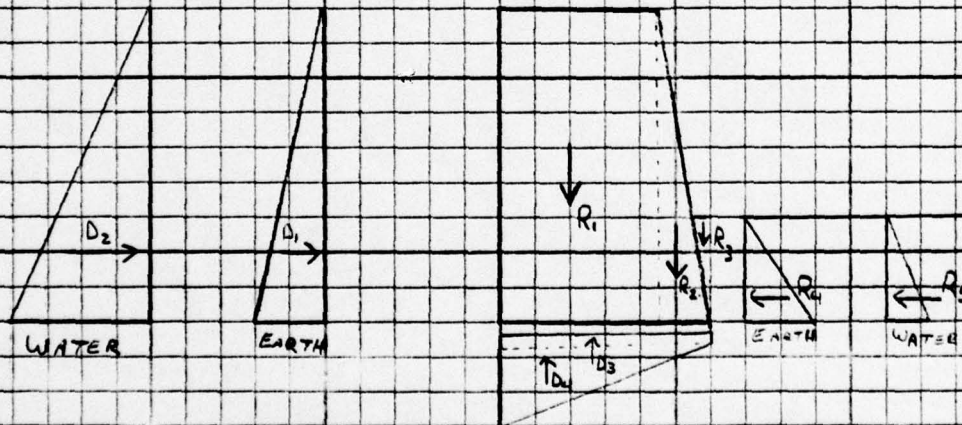
CASE I NORMAL CONDITIONS

Stability analyses for this structure indicate that the factors of safety for all conditions analyzed are unsatisfactory. Further studies are required to better assess the structural integrity of the dam. An investigation of the concrete spillway section should be made to determine the exact limits and dimensions of the concrete and using this information, the structural stability should be reanalyzed. This study should be commenced within six months of the date of final approval of this report.
